Exhibit 4 - Photographs

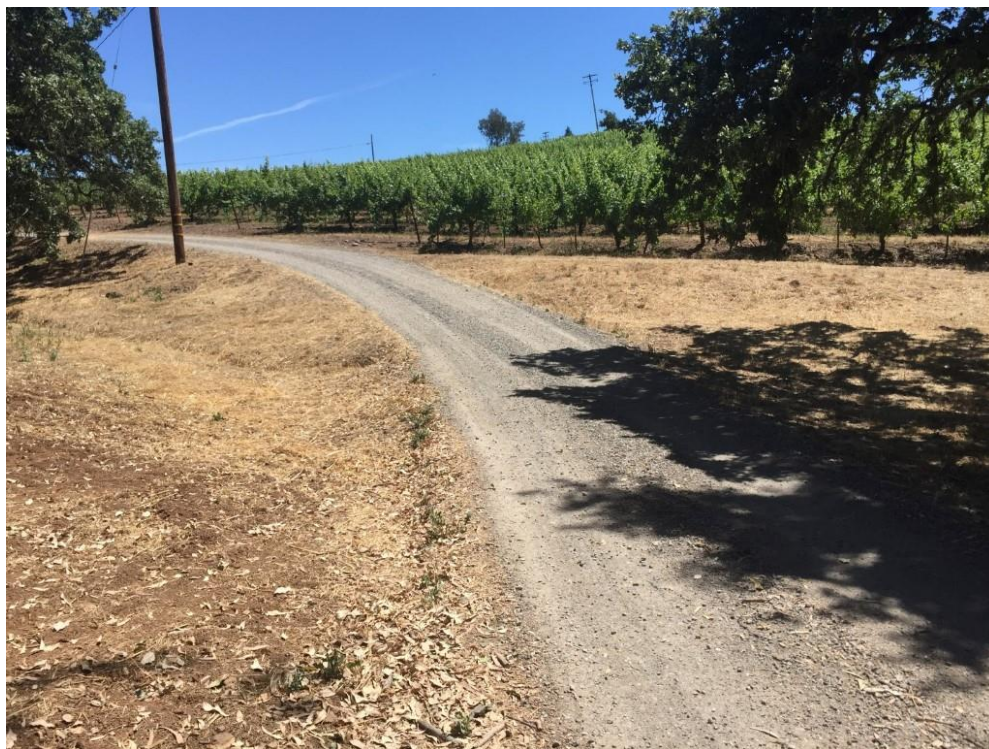
Vineyard #1 – proposed critical dip location

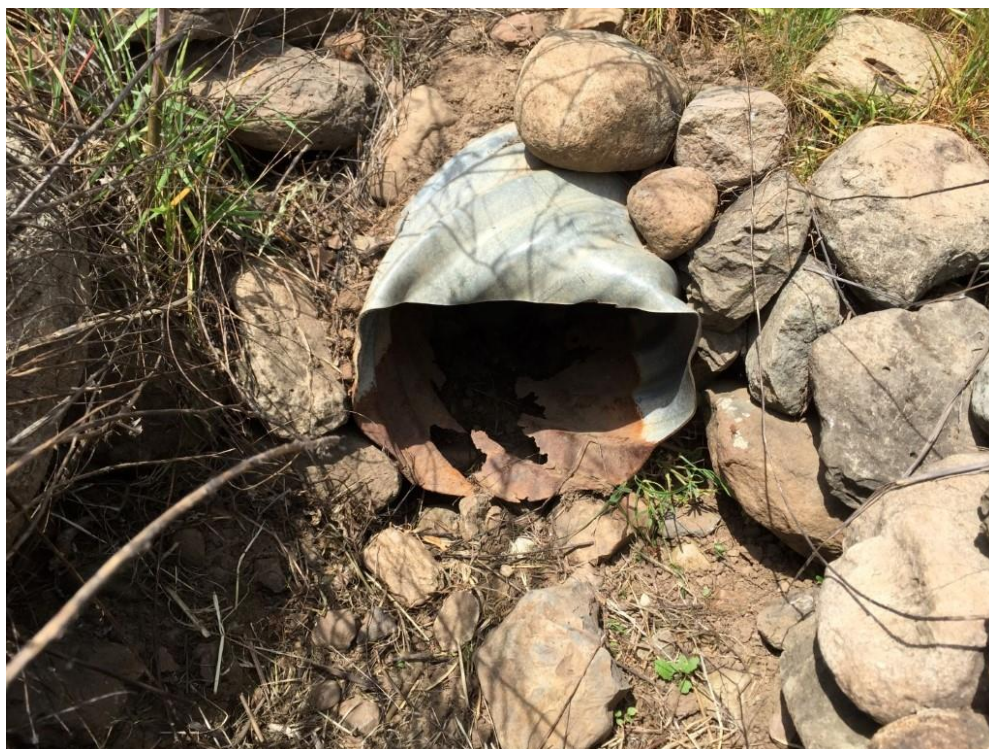
Vineyard # 1 – culvert replacement at Site 2

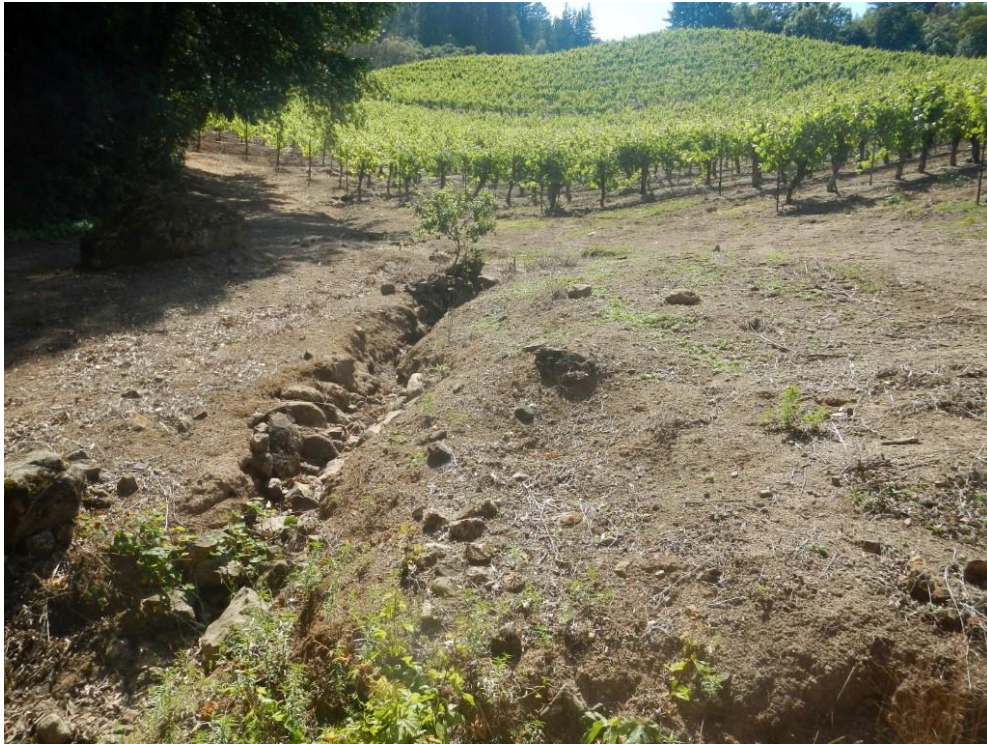
Vineyard # 2 – critical area planting

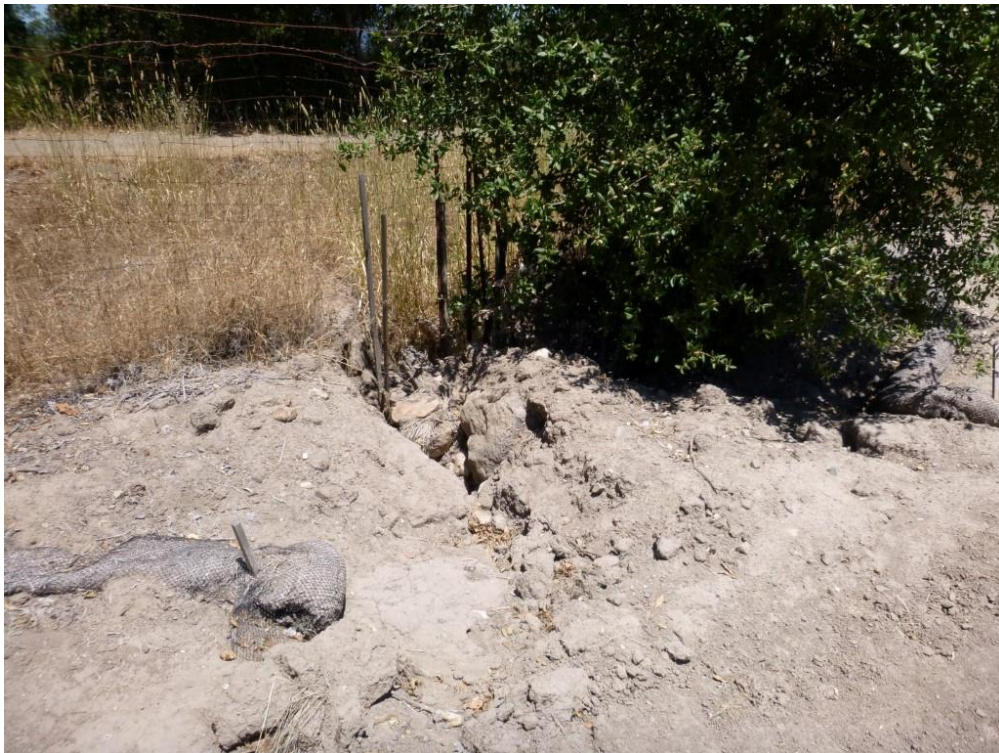
Vineyard # 2 – grade stabilization

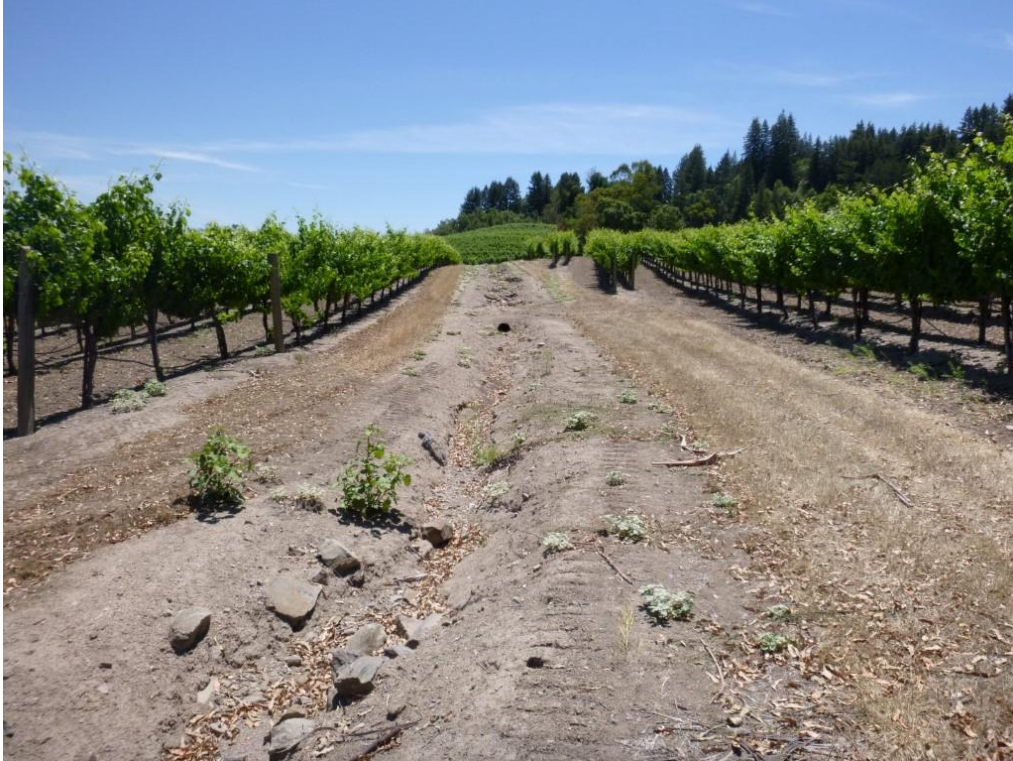
Vineyard # 2 – grassed waterway

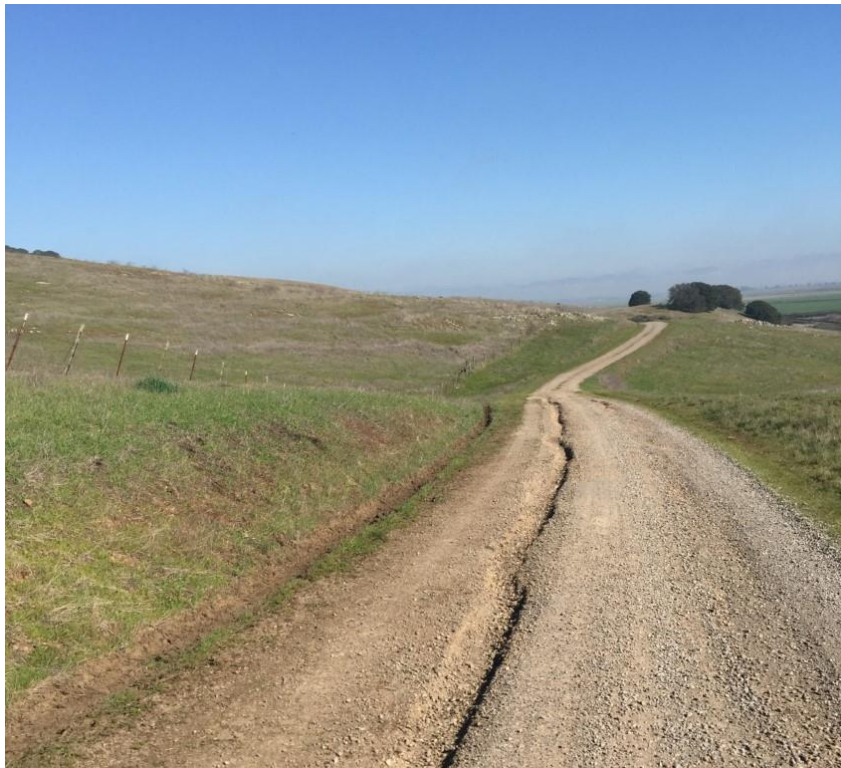
Vineyard #3 – rill on Site 2 right road

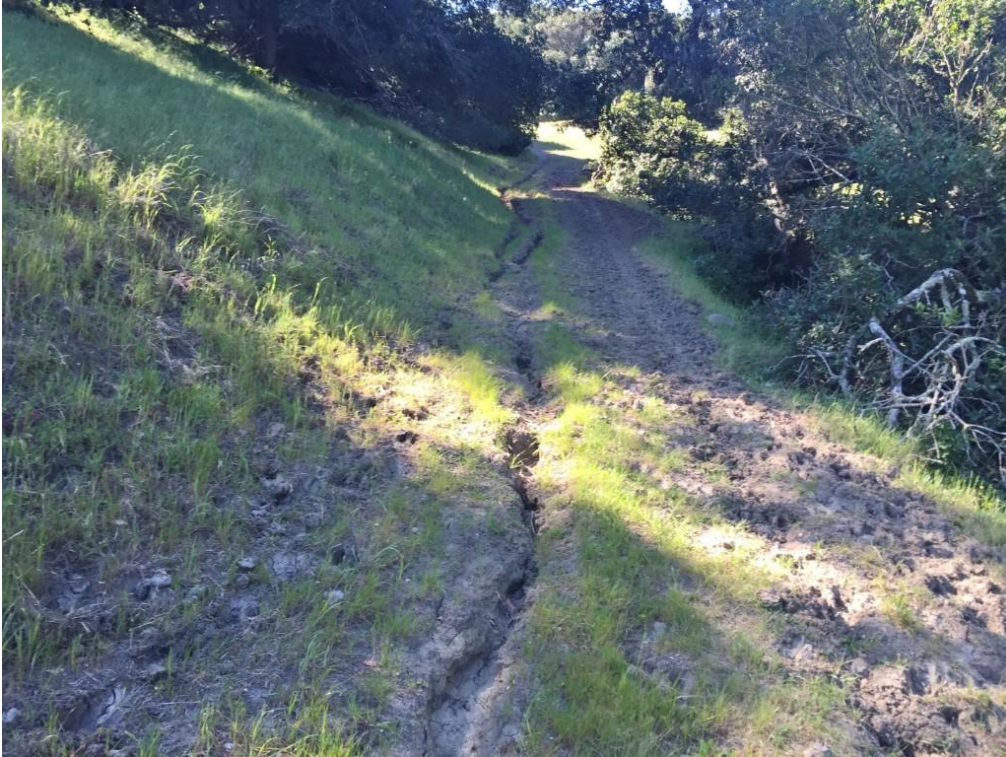
Vineyard #3 – rills on Site 29 right road

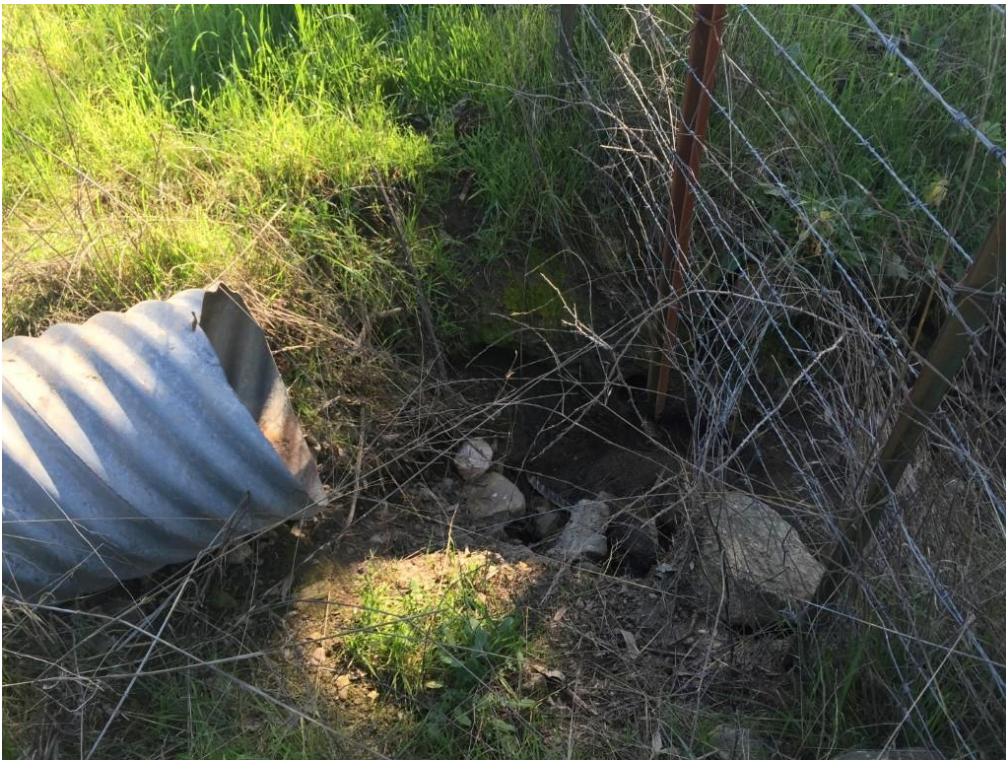
Vineyard #3 – site 6 outlet needing rock

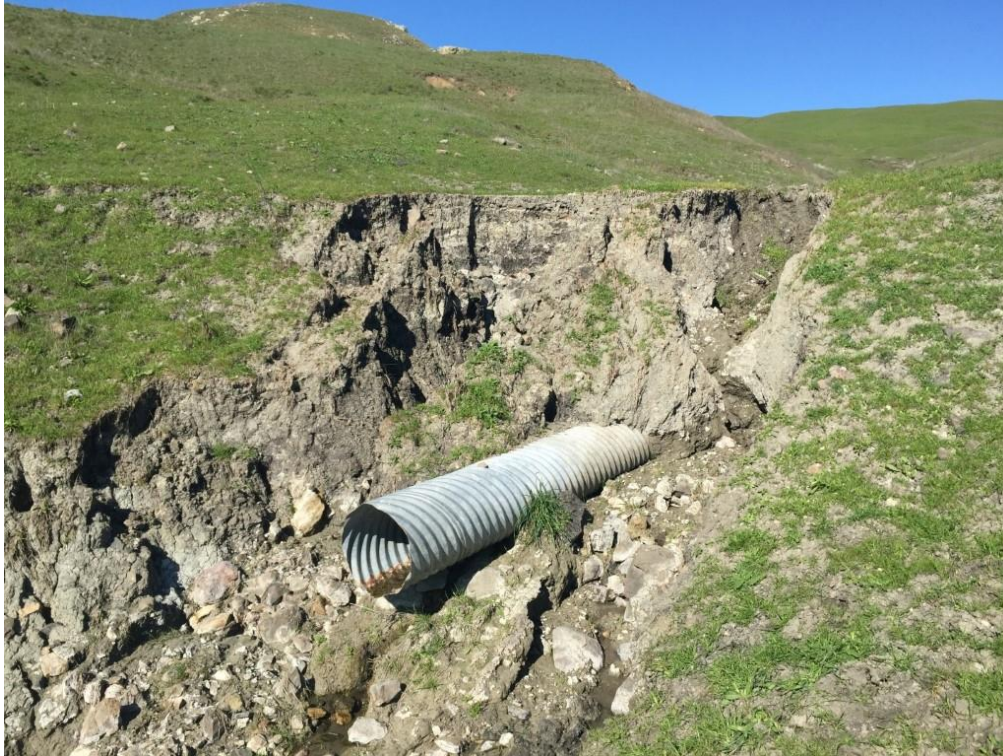
Vineyard #3 - Site 16 wash out

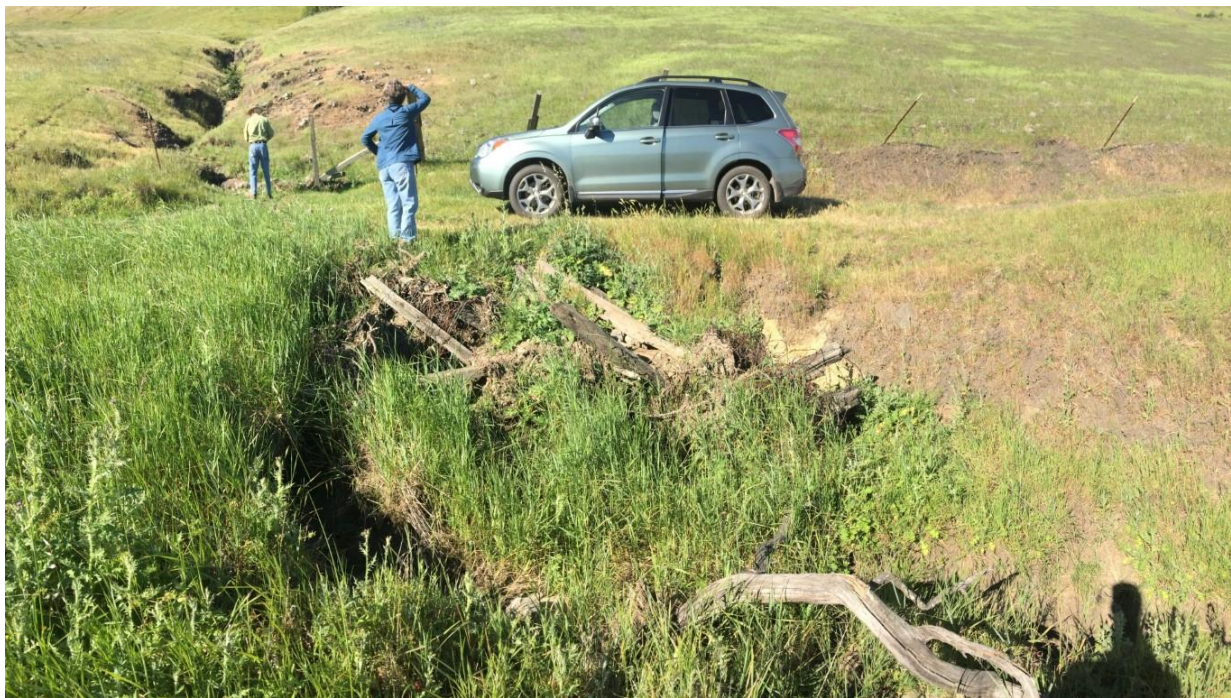
Vineyard #3 – Site 28 armored fill location

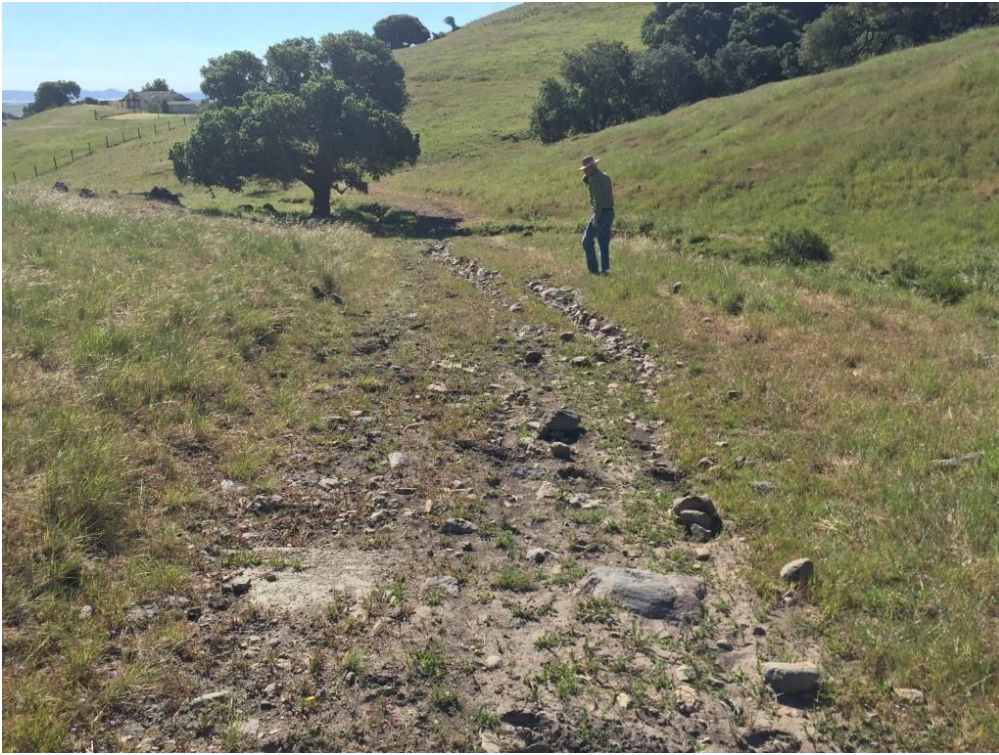
Vineyard #3 – Site 30 ford enhancement

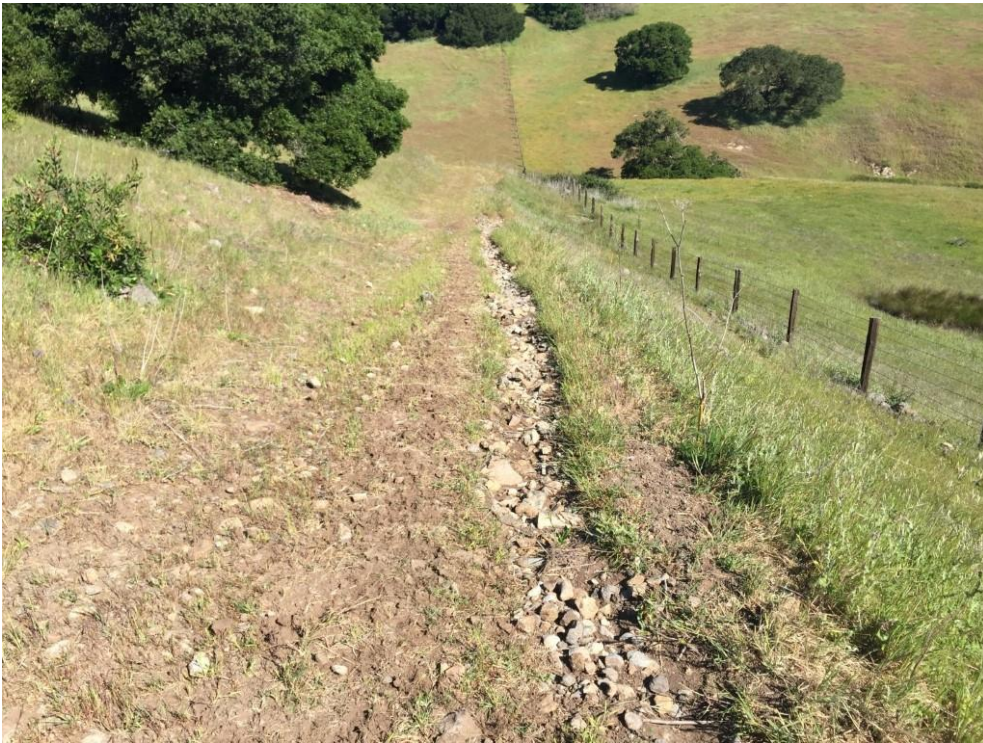
Vineyard #3 - Site 31 right road berm removal

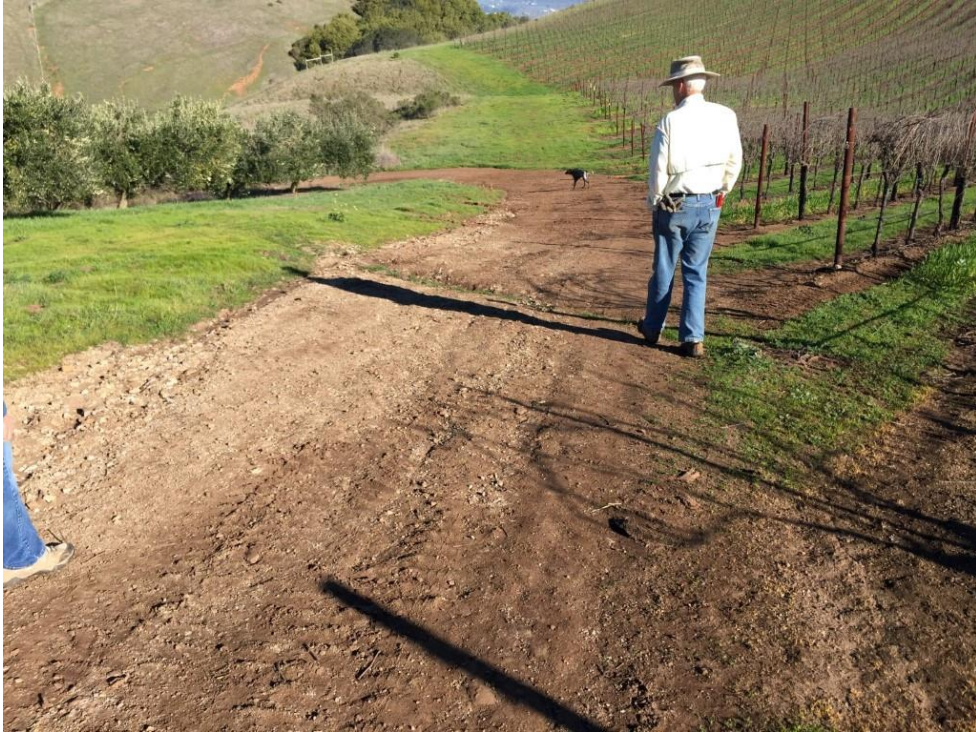
Vineyard #3 – upper vineyard dirt road

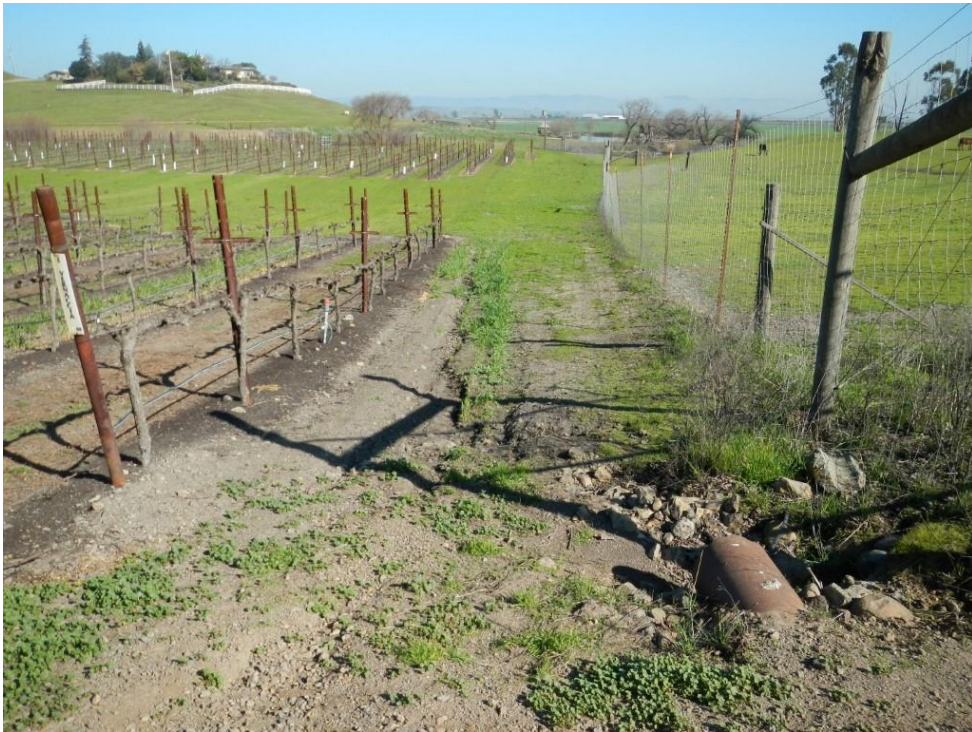
Vineyard #4 – grassed waterway

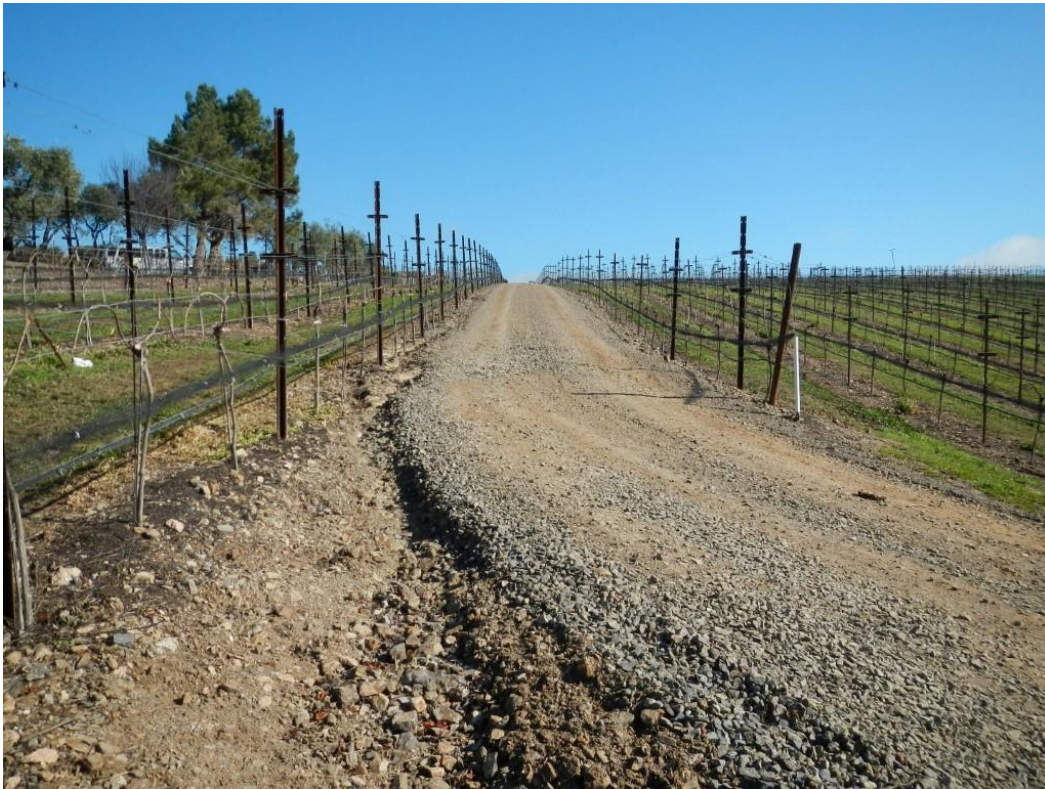
Vineyard #4 – road erosion site
